**Proof Positive:
Fifty (50) Masonry Stain Jobs
That Stood the Test of Time**

**Masonry
Cosmetics,
Inc.**

TABLE OF CONTENTS

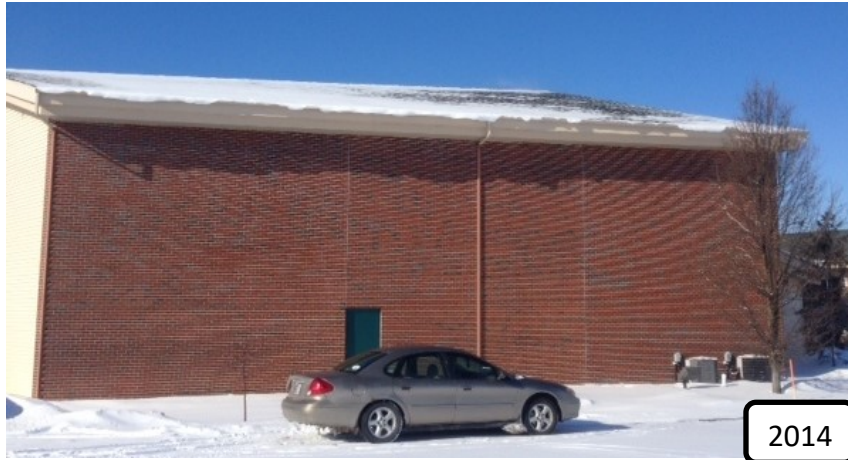
**Church,
Angola, IN—1999**

NOTE: The picture below is before staining with the test panel taped off. We color corrected the majority of the wall to match the area circled. Still looks great 15 years later.

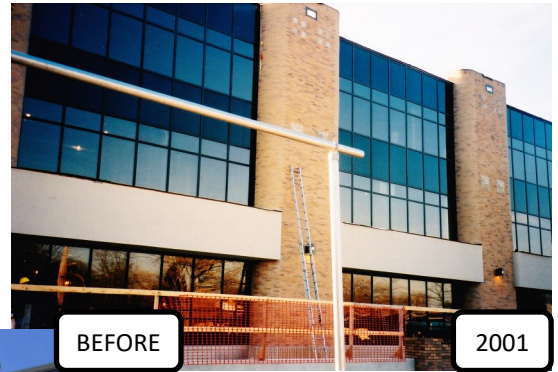
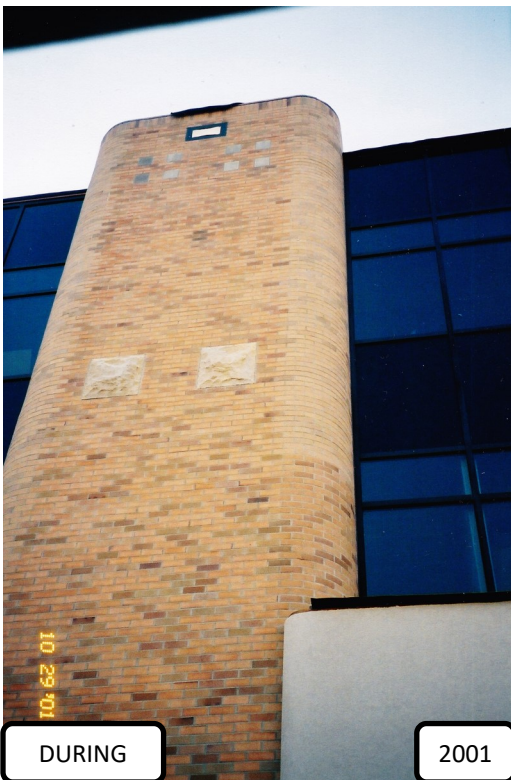
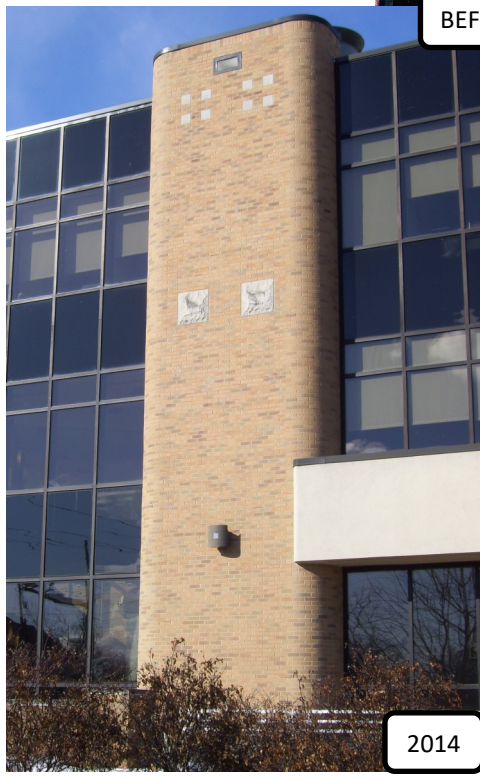
**Blanchard Valley Hospital
Findlay, OH—2001**

In 2001, we were hired to color correct the radial brick shapes on the street –side (only) of the hospital to match brick that were no longer made. Today it looks just as good as when we left 13 years ago.

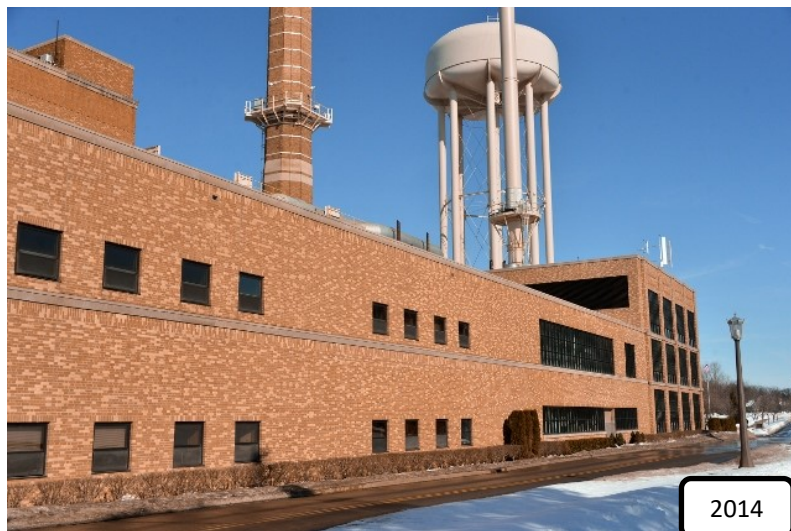
**University of Notre Dame,
Power House, Notre Dame, IN**

Over 23 years and no sign of fading.

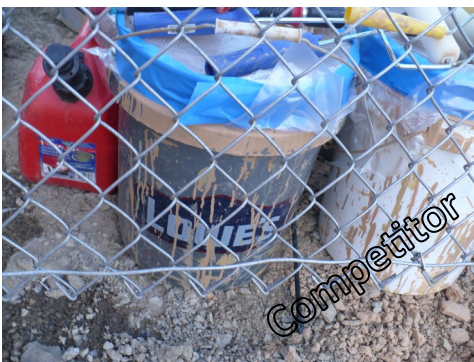
This brick staining company was using paint from Lowe's and watering it down on a school in a different area that we were also working on.

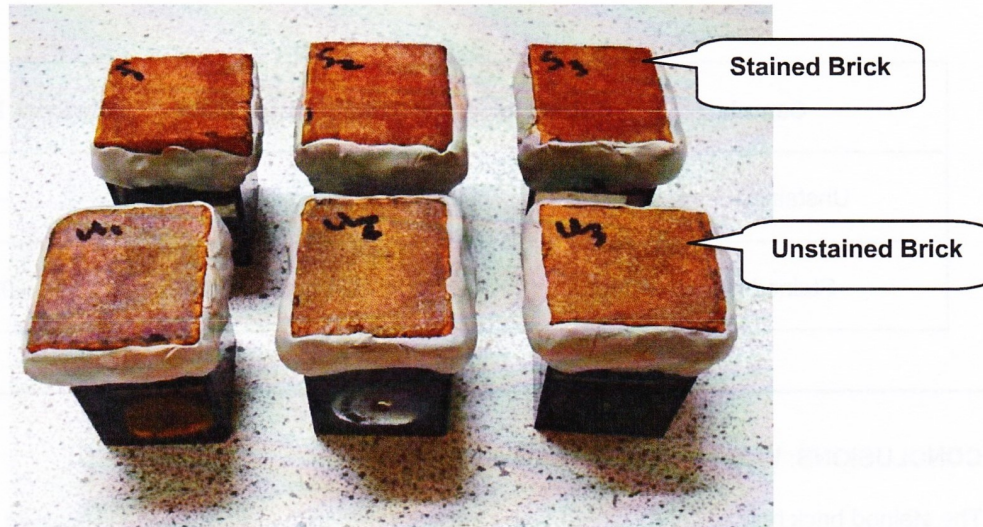
PHOTOGRAPH: Water Vapor Transmission

The samples were placed on laboratory test cells partially filled with distilled water. The sides of the samples were sealed to the top rim of the test cell so that no water vapor could escape. Cells were then weighed and placed in a room maintained at approximately 73°F (23°C) and 30% relative humidity.

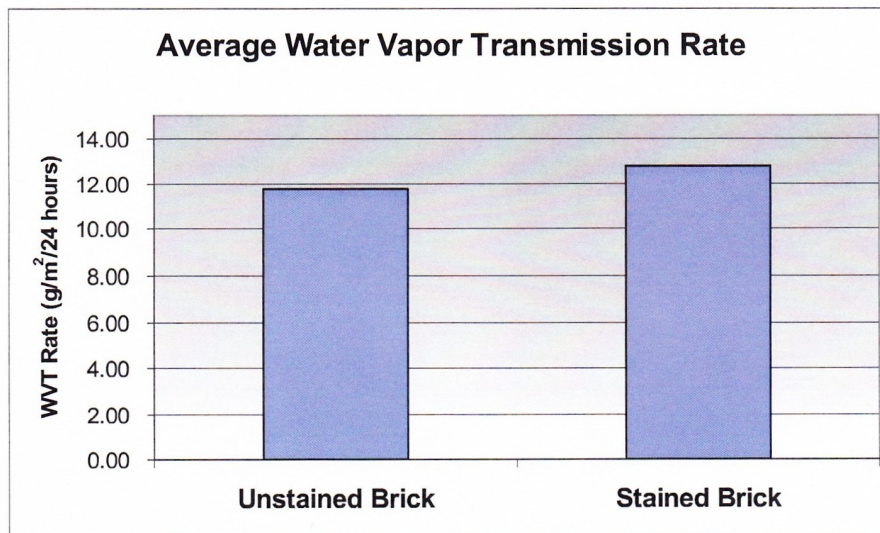
GRAPH: Water Vapor Transmission

Sample	Water Vapor Transmission Rate	Percent Retention
Unstained Brick	11.75 g/m ² /24 hours	---
Stained Brick	12.79 g/m ² /24 hours	>99%

The stained brick had a slightly higher water vapor transmission rate than the unstained brick, indicating that the stain does not inhibit the brick's ability to "breathe".

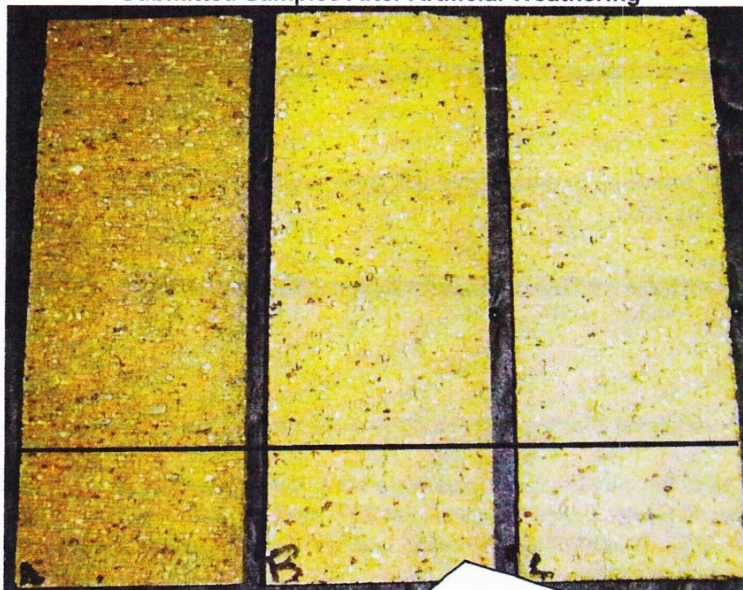
Submitted Samples After Artificial Weathering

The bottom portion of the samples was covered during artificial weathering, and therefore not exposed.

Based on visual evaluation of the samples, there does not appear to be any change in appearance to the surface of the clay brick samples after 500 hours exposure to artificial weathering. As the photograph on the previous page shows, the portion of the samples that was exposed to weathering did not appear any different than the portion of the samples that was not exposed (due to the size of the samples, the bottom 1 ½" of each sample was covered during weathering).

There is a natural color variation in the red stain that occurs in all of the submitted samples; some portions of each sample are darker red than other portions of the sample. This natural variation was not caused by artificial weathering; the samples were submitted with this variation.

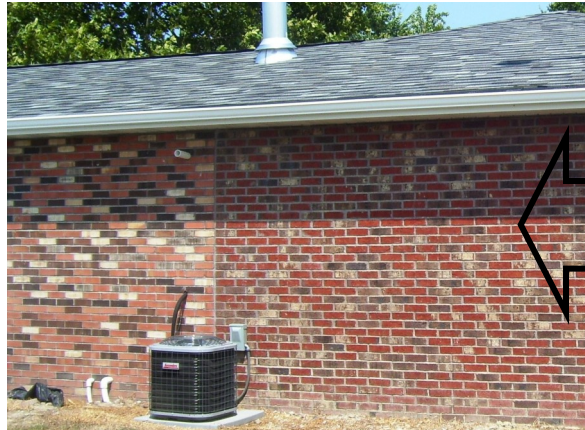
This is an example of what a bad pre-blend can look like. (We never touched this building!)

Here is a sample of poor planning because the wrong color and texture was chosen. See our sample test panel in blue tape below.

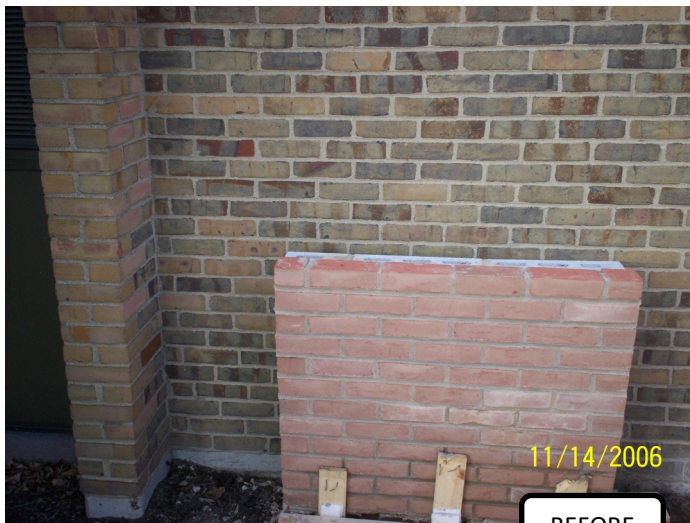
To the left is a job in progress at a school. As we color correct the sample the architect and owner can direct the amount of change in the panel. They can control the color range, details and also the cost. Our process is very flexible, does not seal the brick, keeping it breathable. We also do not leave a sheen or film. Therefore, we can apply our process again over the top if needed, adjusting the color at anytime.

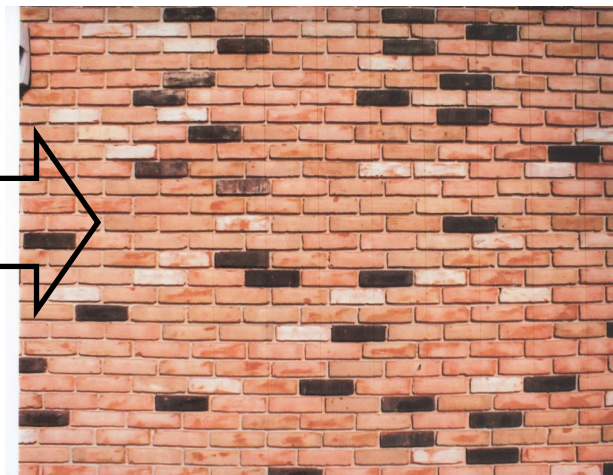
This is a perfect example of a blend that would be difficult for a manufacturer to repeat... No Problem for Masonry Cosmetics!
